Conservation and Restoration of Built Heritage – Europe and the Lions: Assets Integrated Into the Sobrado Dos Toledos – Iguape – Brazil

Abstract: The aim of this article is to present the stages of restoration and conservation of the assets integrated into the Sobrado dos Toledos, in Iguape- Sao Paulo-Brazil, located in southeastern Brazil. The historic building is an important neoclassical architectural landmark built in the first half of the 19th century. It is a place of memory of an important economic moment in the city, that of rice cultivation, driving important investment in large neoclassical style residences. The Sobrado dos Toledos are icons of Portuguese Neoclassicism of the 18th and 19th century. This building is the only example to be found in the entire city that has the striking presence of the monuments that decorate the façade of the mansions. The ornamental images are striking representations of a European elite, a reflection of a period of great economic prosperity, mainly thanks to rice cultivation. We will highlight the two main decorative elements that adorn the façade of the Sobrado dos Toledos: The Lions, a set of two sculptures and the other a statue repre

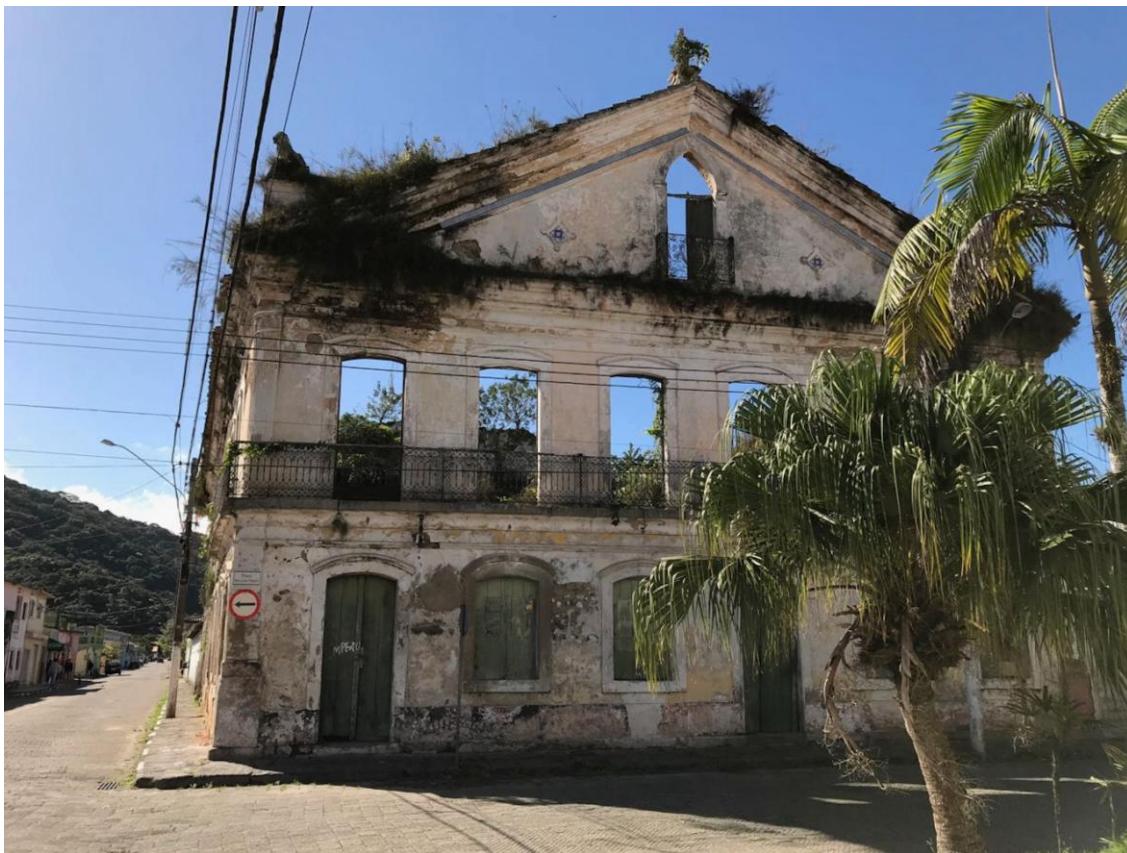
Figure 1- Sobrado dos Toledos, photo from 2018. Available at: <https://www.projete.eng.br/obra/sobrado-dos-toledos>. Dec. 13, 2023.

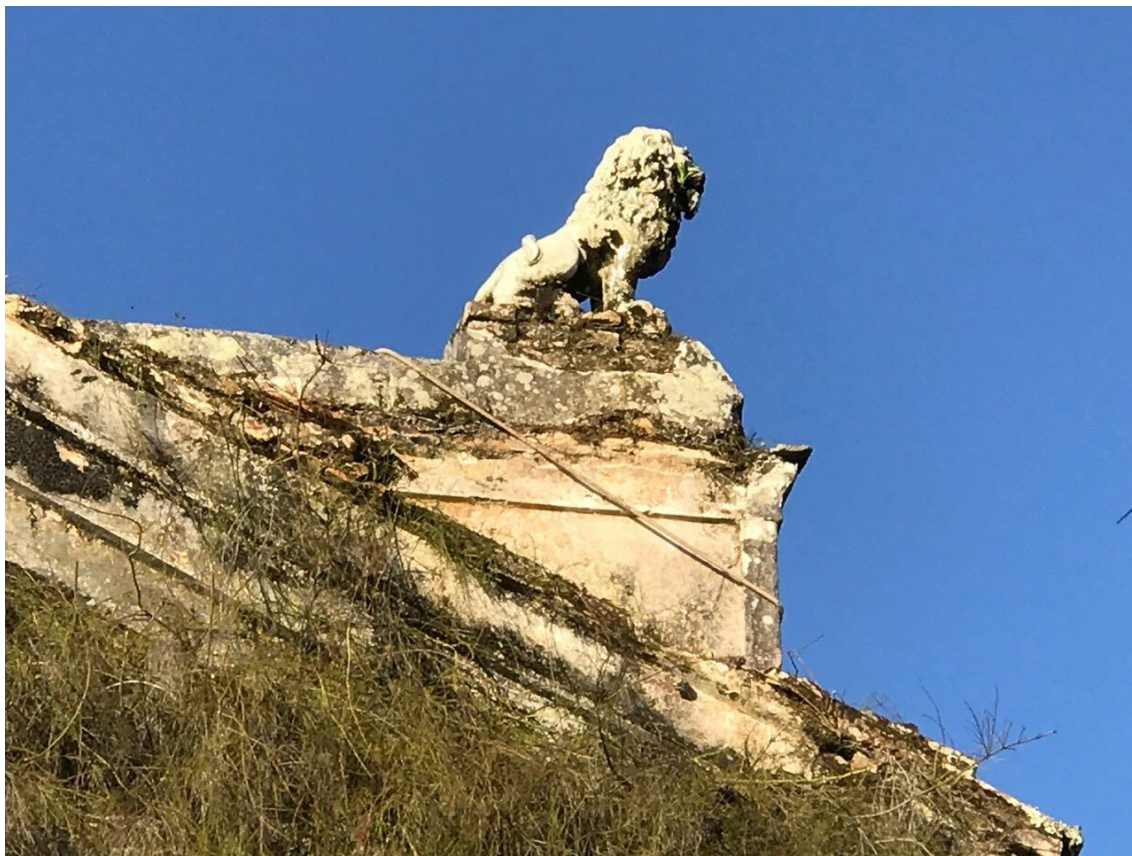
Figure 2. Record of one of the lions at Sobrado dos Toledos.
Atempo Preservation and Restoration Collection, 2013.

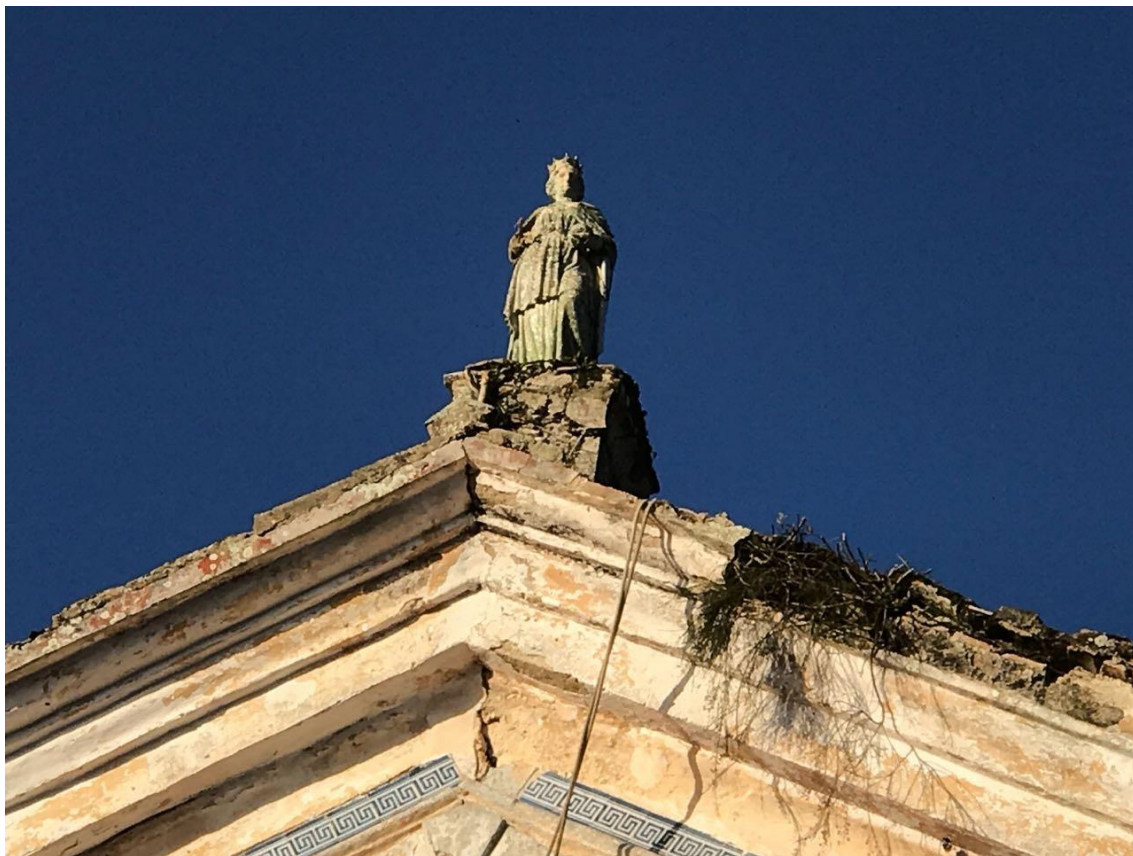
Figure 3-Representation of Europe at the top of the main façade of Sobrado dos Toledos.
Atempo Collection (2013)

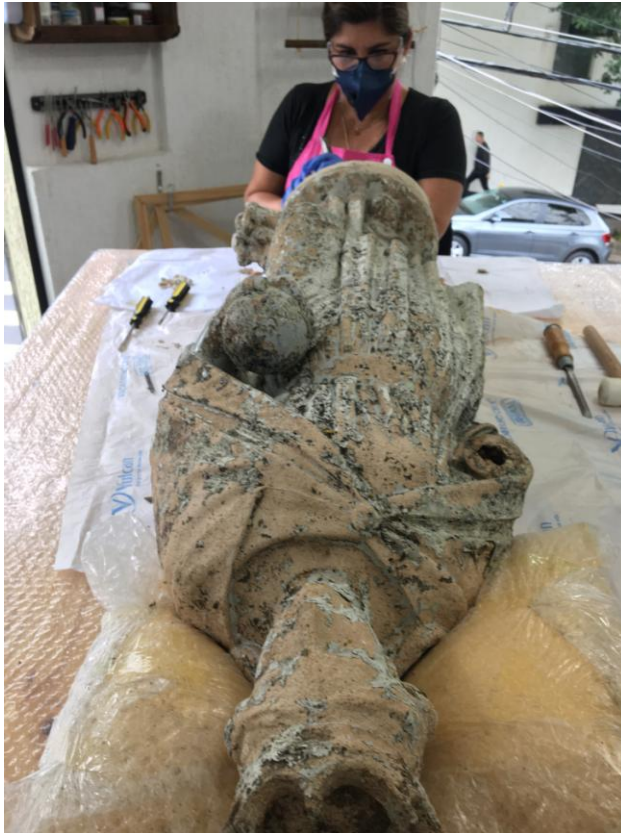
Figure 4-Europe. Photo: Atempo. (2018)

Approx. measurements:
Height: 1.04 m / Base: 30 cm
-Cement on the base.

Pathologies

- Widespread dirt.
- Details of the sculpture are covered with lichens of different green tones.
- Presence of fungi.
- Identification of live cockroaches (*Periplaneta americana*) and spiders.
- Old restoration (some repainting).
- Loss of right arm (Fig. 4).
- Cracks.
- Gap (hole in the piece).
- Loss of glaze (about 90%).
- Extensive loss of substrate.
- Presence of cement in the base.

The identification of the Europa sculpture in the Devesas Factory Catalog was used as a reference for the production of her prosthetic hand and scepter.

- Sanitizing to remove lichen and surface dirt with soft bristle brushes.
- Mechanical removal of incrustations and deposits with precision tools.
- Removal of repaint layers with gel descaler (previously tested) and use of *Lecron*.

- Stuffing the areas of loss with a filler (marble dust, calcium carbonate, polyvinyl alcohol, acrylic putty, deionized water, and pure pigments).
- Preparation of the prosthetic arm and scepter of Europe:

- Making the prosthesis in stone plaster using the blue silicone mold.
- Fixation of the prosthesis with a pin made of non-oxidizing material, positioned as shown in the Devesas Catalog.

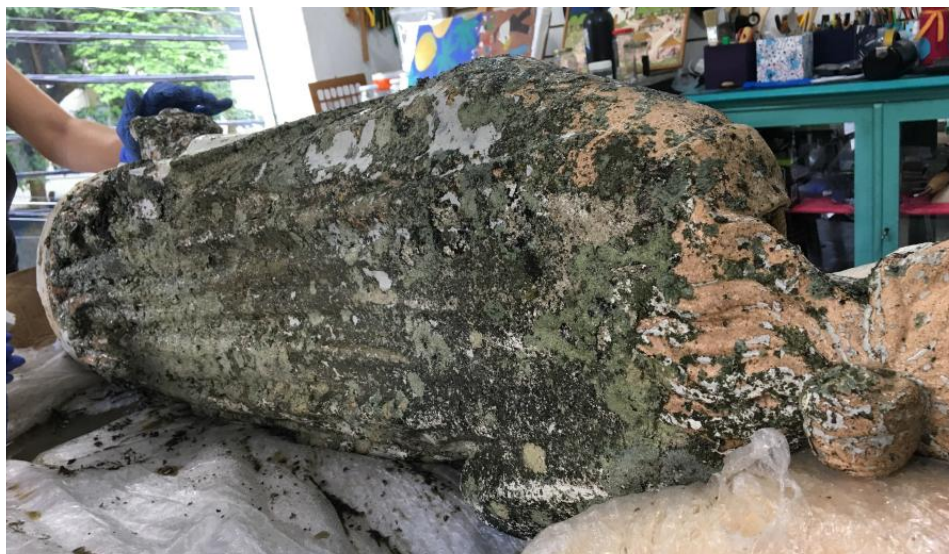
Figure 4.1- Back detail - Europe. Photo: Duarte, Adriana V. (2018).

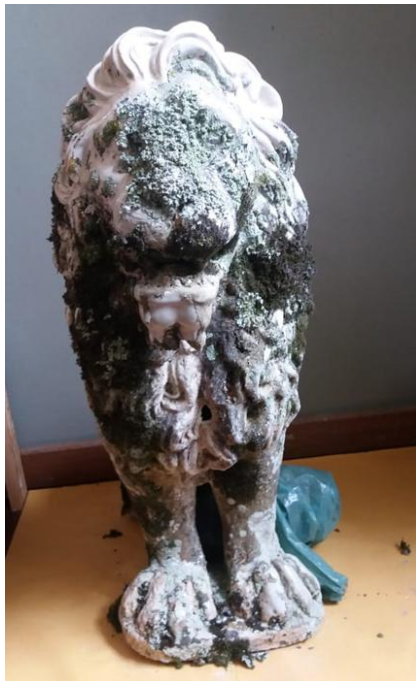
Figure 5- Lion 1. Photo: Atempo (2018)

Approx. measurements:
Height: 70 cm / Base: 53 cm

Pathologies:

- Widespread dirt.
- Details of the sculpture are covered with light greenish lichen.
- Presence of spiders.
- Widespread incrustations.
- Blistering.
- Gap (hole).
- Areas of cracks (small lines) and fissures (cracks of varying depth).
- Loss of glaze (peeling) in several areas (about 40%).
- Old interventions (repainting in several areas).
- Peeling of paint layers.
- Small generalized fractures.
- Detached hindpaws.
- Presence of cement in the base.

- Spray application of a quaternary ammonia-based biocide diluted with deionized water against biological agents.
- Fixation of loose hind paws with a stainless-steel pin and epoxy-based adhesive.

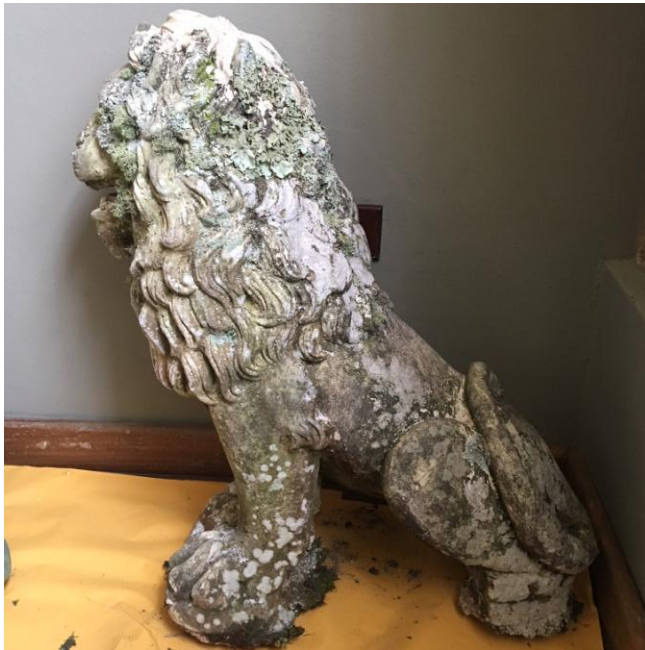
Figure 5.1-photo taken from the lion's side- Lion 1. Photo:Atempo (2018)

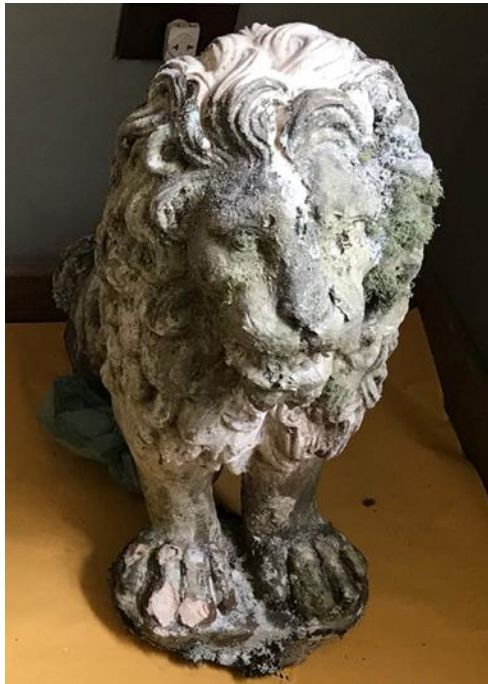
Approx. measurements:

Height: 70 cm / base: 53 cm

Figure 5.2 Front detail. Photo: Atempo, 2018

Front:
-Fractures in the toes

Pathologies:

- Widespread dirt.
- Details of the sculpture covered with lichen of various colors.
- Presence of spiders.
- Small generalized fractures.
- Partial fracture of two toes on the front paw.
- One (1) missing hindpaw.
- Widespread incrustations.
- Areas of cracks (small lines) and fissures (cracks of varying depth).
- Blistering.
- Loss of glaze (peeling) in several areas.
- Old interventions (repainting in several areas).
- Peeling of paint layers.

- Loss of ceramic material.
- Presence of cement in the base.

- Molding of the existing paw in a blue silicone mold.
- Creation of a replica (paw) in stone plaster from the blue silicone mold.
- Fixation of paw with a stainless-steel pin and epoxy-based adhesive.
- Finishing with leveling compound and layers of *Paraloid B72* resin diluted in xylene, pigments and protective layers.
- Stuffing the areas of loss with a filler (marble dust, calcium carbonate, polyvinyl alcohol, acrylic putty, and deionized water).
- Chromatic reintegration with *Paraloid B72* resin and pure pigments.
- Application of two layers of *Paraloid B72* resin diluted in xylene and *Tinuvin 292* for the final protection of the pieces exposed to the elements, as well as to restore the shine of the lost glaze.

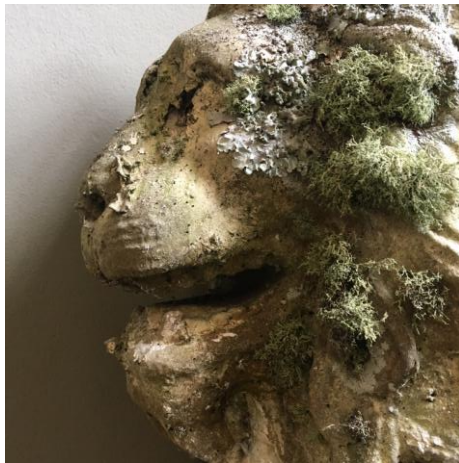
Side detail - head

Figure 5.3- Front and head detail - Lion 2. Photo: Atempo. (2018)

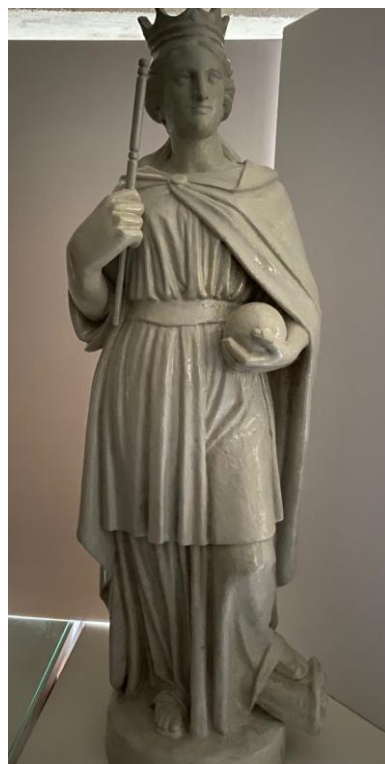
Figure 6- Sculpture of Europe restored.

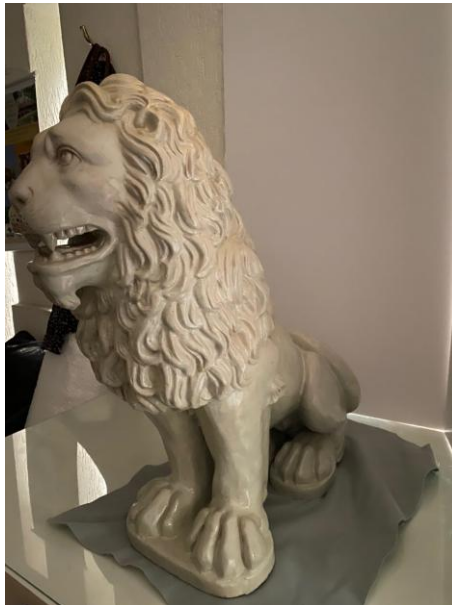
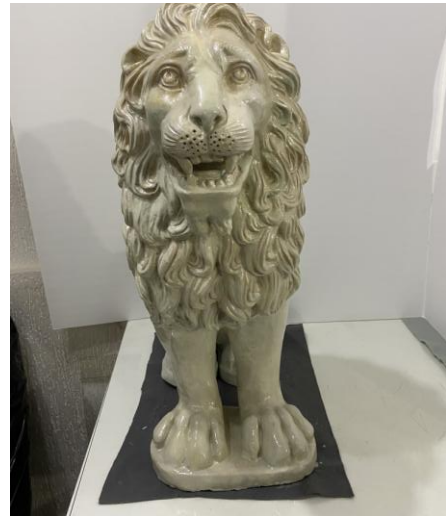
Figure 7a/7b- Sculptures of the Lions restored. (Photo: Atempo).

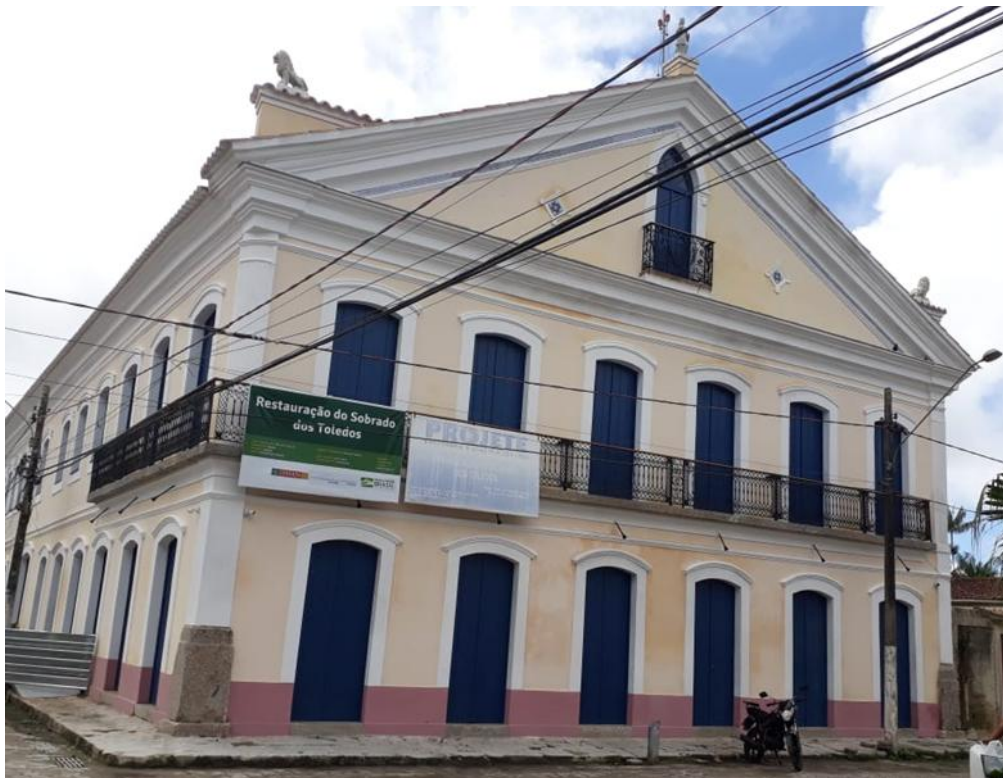
The entire restoration process lasted an average of ten weeks. Once the pieces were restored, they were returned to their original location on the plateau of the Sobrado dos Toledos building, as shown in the pictures below:

Figure 8- Placement of pieces on the plateau of the Sobrado dos Toledos building. Photo: personal archive (2018).

It is recommended to carry out quarterly preventive maintenance, which means sanitizing with a soft brush and non-pressurized water to remove the biological agents which are accumulated daily.
